**Flood Control Project Maintenance  
Levee Inspections**  
**LMA District Cover Sheet**  
**Spring 2018 Levee Inspection Results**

**Reclamation District No. 0341 Sherman Island**

**Spring 2018 Levee Inspection Results**

**Levee Inspection Report By Mile - Spring 2018**

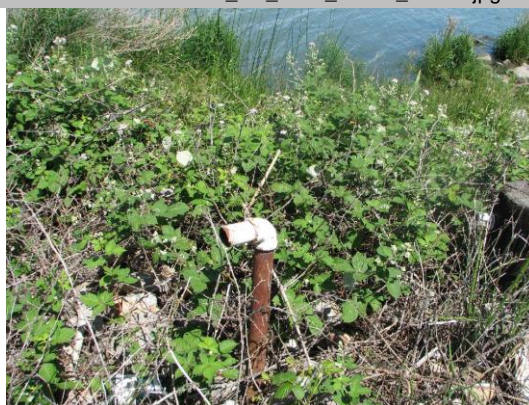
Photo 2 of 2 : UCIP\_SP\_2018\_22262\_37952.jpg

View of waterward side air vent pipe could be associated with crossing.

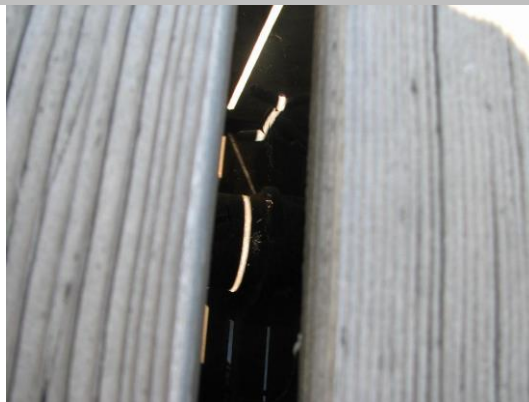
Photo 2 of 3 : UCIP\_SP\_2018\_22263\_37961.jpg

Unable to confirm number of pipes.

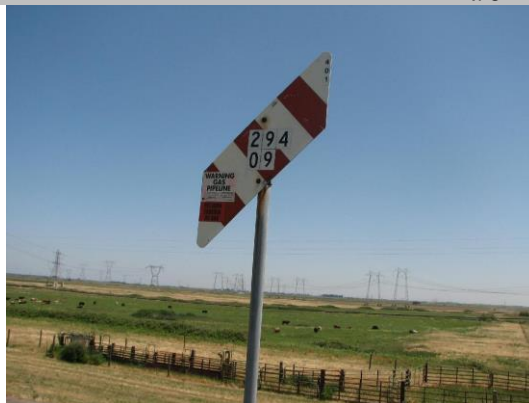
Photo 1 of 2 : UCIP\_SP\_2018\_22267\_37978.jpg

FS\_ID:22267  
DS\_ID:24193  
EP\_NO: 15777  
Repair Type: Non-Urgent  
Crossing Status: Indicator Found  
UCIP Comments: Need to contact owner to determine status of crossing. Need date of last inspection and confirmation that crossing is still in operable condition. Multiple crossings in general area need to clarify which pipes are in this levee section.  
FIELD\_STRUCT\_DESC: 42-inch steel natural gas line through the levee, bored 30-feet below the channel and both levees. Utility marker contact information includes Contact prior to Excavation call 1-800-227-2600 or Emergency Contact 1-800-811-4111. (42-inch line authorized under authorized Permit No. 15777, 1993 - PGT - PG&E Pipeline Expansion Project) [Additional Reference(s): LMA encroachment station (STA) reference based on Map of Evacuation Route, Reclamation District 341 Sherman Island by Wagner Bonsignore Consulting Civil Engineers, A Corporation dated July 2012, STA 826+00]

Marker located on landward side.

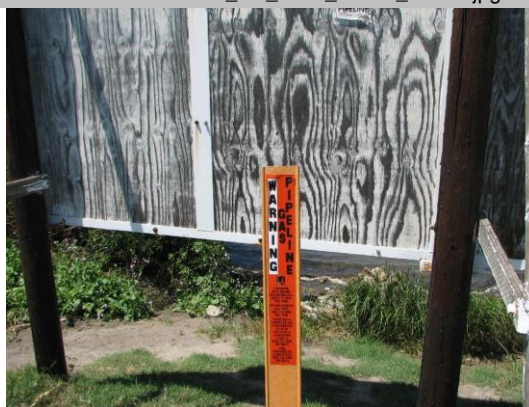
Photo 2 of 2 : UCIP\_SP\_2018\_22267\_37977.jpg

Marker located on waterward side.

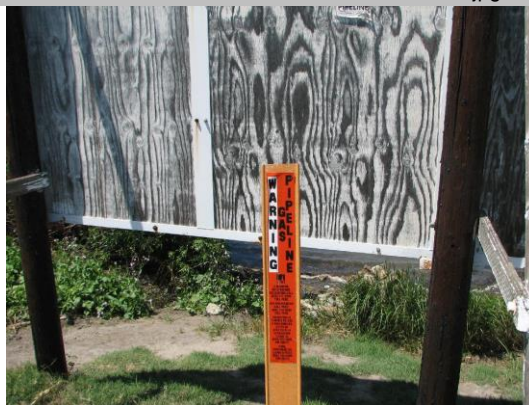
Photo 2 of 2 : UCIP\_SP\_2018\_22268\_37979.jpg

FS\_ID:22268  
DS\_ID:24218  
EP\_NO: N/A  
Repair Type: Non-Urgent  
Crossing Status: Indicator Found  
UCIP Comments: Need to contact owner to determine status of crossing. Need date of last inspection and confirmation that crossing is still in operable condition. Multiple crossings in general area need to clarify which pipes are in this levee section.  
FIELD\_STRUCT\_DESC: Gas line crossing through the levee. Utility marker contact information includes Contact prior to Excavation call 1-800-227-2600 or Emergency Contact 1-800-743-5000. [Additional Reference(s): USACE Sacramento O&M Manual Unit No. 101, February 1962, (HLM 7.08). LMA encroachment station (STA) reference based on Map of Evacuation Route, Reclamation District 341 Sherman Island by Wagner Bonsignore Consulting Civil Engineers, A Corporation dated July 2012, STA 823+00]  
FS Date: 5/6/2009

Utility marker located on waterward side.

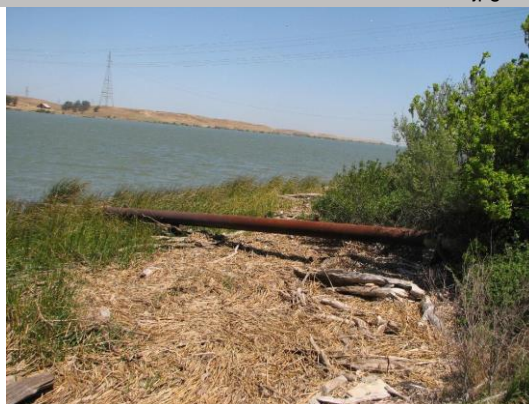
Photo 2 of 3 : UCIP\_SP\_2018\_22293\_38040.jpg

View of crossing located on waterward side.

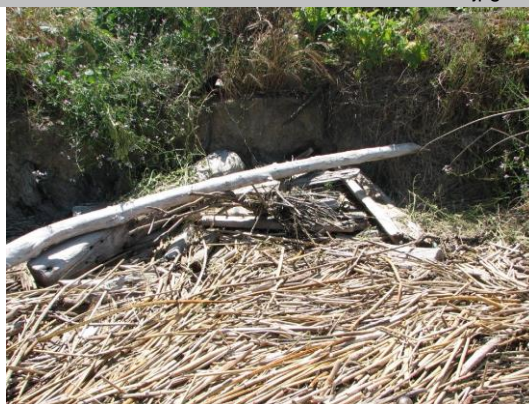
Photo 2 of 3 : UCIP\_SP\_2018\_22294\_38050.jpg

Comment Code					
Inspector Comment					
FS_ID:22294 DS_ID:24243 EP_NO: 10799 Repair Type: Non-Urgent Crossing Status: Found UCIP Comments: Will need to contact owner. Need to obtain maintenance records and clarify modifications made at to crossing (size). Also important to note that DWR DOE was out in the field during our pipe inspection they were conducting pipe evaluation for pipe replacement. Need to contact DWR DOE to determine location of pipe replacement. FIELD_STRUCT_DESC: 12-inch steel irrigation pipe through the levee, 5.3 feet below the crown. Steel cutoff wall around pipe at center of levee. Siphon breaker on landside (LS) shoulder. Steel (not concrete as mentioned in historical records) pipe riser on the LS. 2-inch pipe sleeve around pipe at waterside (WS) shoulder. Rock revetment on WS slope. Pipe exposed along WS slope. (12-inch pipe authorized under Permit No. 10799, 1977 - G. Celli) [Additional Reference(s): DWR Levee Log, 1992. LMA encroachment station (STA) reference based on Map of Evacuation Route, Reclamation District 341 Sherman Island by Wagner Bonsignore Consulting Civil Engineers, A Corporation dated July 2012, STA 799+00] FS Date: 5/6/2009

Concrete headwall located on waterward side.

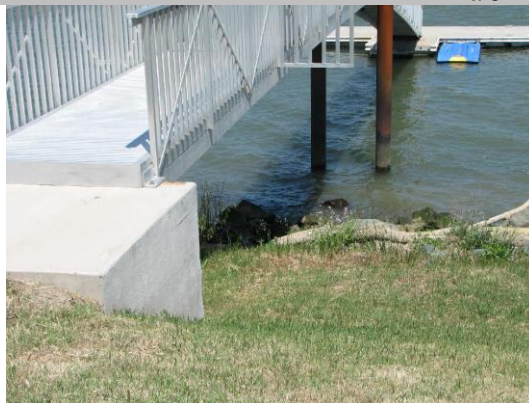
Photo 1 of 3 : UCIP\_SP\_2018\_22303\_38062.jpg

Comment Code					
Inspector Comment					
FS_ID:22303 DS_ID:24246 EP_NO: N/A Repair Type: Non-Urgent Crossing Status: Found UCIP Comments: Need to determine the status of conduit--has construction been completed? FIELD_STRUCT_DESC: Four 2.5-inch conduits sleeved through 12-inch steel pipe through the levee at an unknown depth below the levee crown. Boat launching dock and ramp are located on the waterside (WS). [Additional Reference(s): LMA encroachment station (STA) reference based on Map of Evacuation Route, Reclamation District 341 Sherman Island by Wagner Bonsignore Consulting Civil Engineers, A Corporation dated July 2012, STA 778+00] FS Date: 5/6/2009

View of waterward side. Conduit goes through concrete structure connecting walkway.

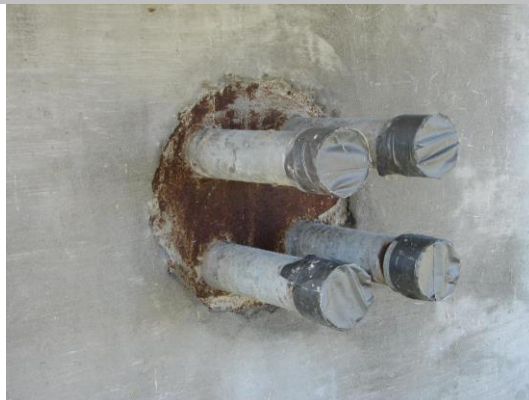
Photo 2 of 3 : UCIP\_SP\_2018\_22303\_38061.jpg

Conduits exposed on waterward side.

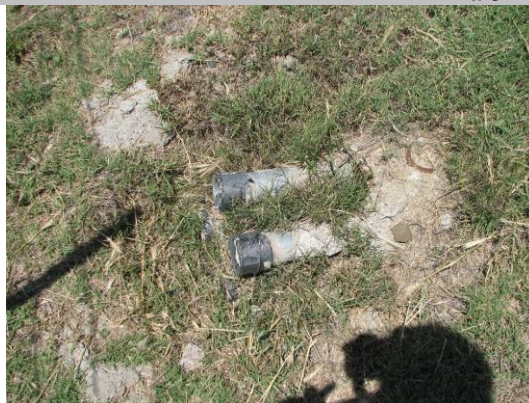
Photo 3 of 3 : UCIP\_SP\_2018\_22303\_38060.jpg

Comment Code						
Inspector Comment						
FS_ID:22303 DS_ID:24246 EP_NO: N/A Repair Type: Non-Urgent Crossing Status: Found UCIP Comments: Need to determine the status of conduit--has construction been completed? FIELD_STRUCT_DESC: Four 2.5-inch conduits sleeved through 12-inch steel pipe through the levee at an unknown depth below the levee crown. Boat launching dock and ramp are located on the waterside (WS). [Additional Reference(s): LMA encroachment station (STA) reference based on Map of Evacuation Route, Reclamation District 341 Sherman Island by Wagner Bonsignore Consulting Civil Engineers, A Corporation dated July 2012, STA 778+00] FS Date: 5/6/2009

View of conduit on landward side. Four 2.5-inch conduits through levee not in use yet.

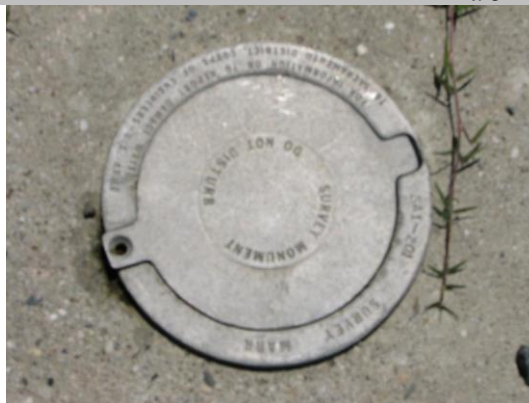
Photo 1 of 3 : UCIP\_SP\_2018\_22306\_38067.jpg

FS\_ID:22306  
 DS\_ID:24130  
 EP\_NO: 3494  
 Repair Type: Non-Urgent  
 Crossing Status: Indicator Found  
 UCIP Comments: Need to contact owner to determine status of crossing. Need date of last inspection and confirmation that crossing is still in operable condition.  
 FIELD\_STRUCT\_DESC: 1 of 2: 26-inch concrete encased steel gas line through the levee, 5.1 feet below the crown. Concrete cutoff wall around pipe at center of levee. Location sign on waterward shoulder. Rock revetment on waterward slope. Contact number listed on marker out in the field 1-800-811-4111. (two 26-inch lines authorized under Permit No. 3494, 1961 - Pacific Gas and Electric Company [PG&E])  
 [Additional Reference(s): DWR Levee Log, 1992. [LMA encroachment station (STA) reference based on Map of Evacuation Route, Reclamation District 341 Sherman Island by Wagner Bonsignore Consulting Civil Engineers, A Corporation dated July 2012, STA 756+00]

Survey marker found at this location.

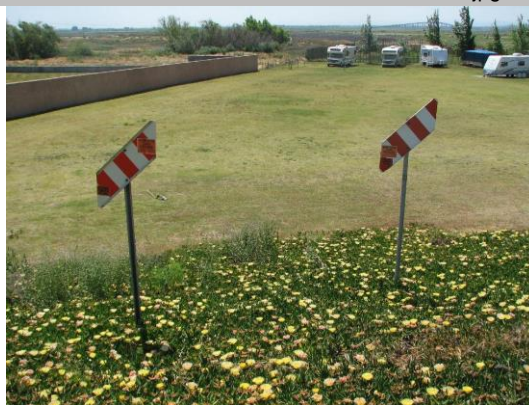
Photo 2 of 3 : UCIP\_SP\_2018\_22306\_38066.jpg

Gas line markers visible on landward side.

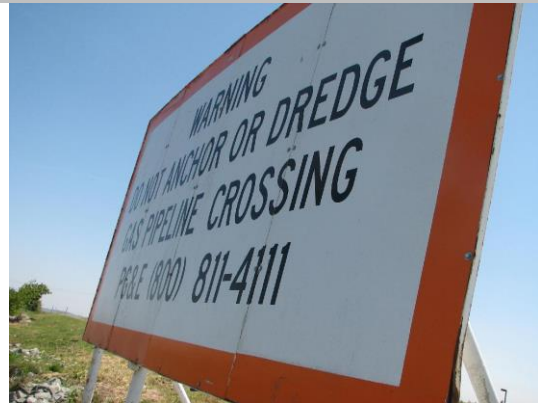
Photo 3 of 3 : UCIP\_SP\_2018\_22306\_38065.jpg

Comment Code						
Inspector Comment						
FS_ID:22306 DS_ID:24130 EP_NO: 3494 Repair Type: Non-Urgent Crossing Status: Indicator Found UCIP Comments: Need to contact owner to determine status of crossing. Need date of last inspection and confirmation that crossing is still in operable condition. FIELD_STRUCT_DESC: 1 of 2: 26-inch concrete encased steel gas line through the levee, 5.1 feet below the crown. Concrete cutoff wall around pipe at center of levee. Location sign on waterward shoulder. Rock revetment on waterward slope. Contact number listed on marker out in the field 1-800-811-4111. (two 26-inch lines authorized under Permit No. 3494, 1961 - Pacific Gas and Electric Company [PG&E]) [Additional Reference(s): DWR Levee Log, 1992. [LMA encroachment station (STA) reference based on Map of Evacuation Route, Reclamation District 341 Sherman Island by Wagner Bonsignore Consulting Civil Engineers, A Corporation dated July 2012, STA 756+00] FS Date: 5/6/2009

Gas line crossing sign located on waterward side.

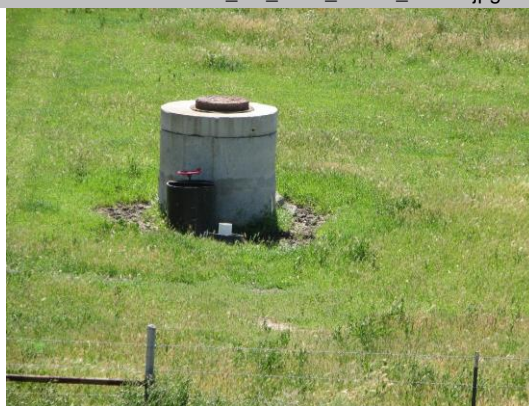
Photo 1 of 3 : UCIP\_SP\_2018\_22309\_38075.jpg

Comment Code					
Inspector Comment					
FS_ID:22309 DS_ID:24247 EP_NO: N/A Repair Type: Non-Urgent Crossing Status: Found UCIP Comments: 7/6/2016 Meet with Joel McElroy, District Representative, at site. DWR Bay Delta Division owns pipe. Pipe is active. Need to contact owner to determine permit authorizing pipe crossing. (DWR UCIP - O. Magana) 05/06/2009 New record found in the field. Unable to find any information for crossing during DWR desk study. Will need to find the owner and obtain records for crossing. Need to coordinate with CVFPB. (DWR UCIP - O. Magana) FIELD_STRUCT_DESC: 10-inch steel irrigation pipe through the levee, at a shallow depth below the crown. Air vent on the waterside (WS). Distribution box with slide gate and observation well on the landside (LS). Pumping station on the LS. Rip rap located on WS. [Additional Reference(s): LMA encroachment station (STA) reference based on Map of Evacuation Route, Reclamation District 341 Sherman Island by Wagner Bonsignore Consulting Civil Engineers, A Corporation dated July 2012, STA 751+00] FS Date: 5/6/2009

Concrete stand pipe and gate valve located on landward side.

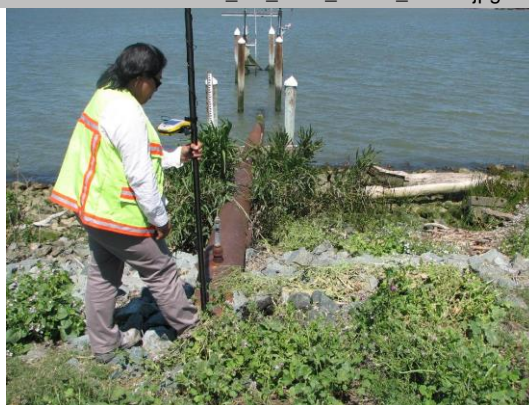
Photo 2 of 3 : UCIP\_SP\_2018\_22309\_38076.jpg

Overview of crossing on waterward side.

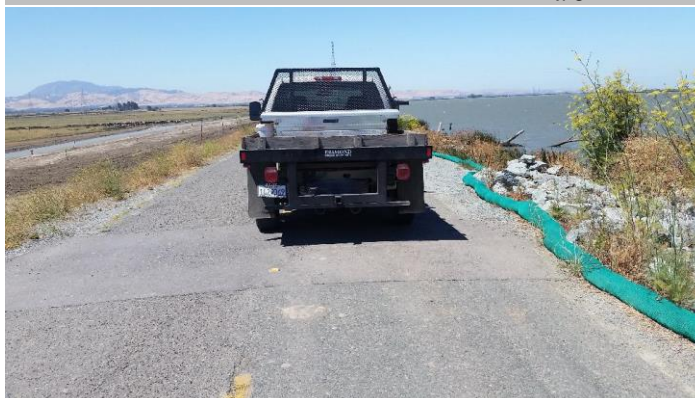
Photo 3 of 3 : UCIP\_SP\_2018\_50082\_75943.jpg

Comment Code					
Inspector Comment					
FS_ID:50082 DS_ID:25470 EP_NO: N/A Repair Type: Non-Urgent Crossing Status: Found UCIP Comments: 7/6/2016 Pipe found in 2009 has been removed and new pipe installed. Unable to determine permit authorizing work. Need to coordinate with owner to obtain details regarding permit and pipe install. (DWR UCIP - omagana) FIELD_STRUCT_DESC: UNK size pipe through the levee. (unknown permit authorizing work; previous 10-inch pipe removed between 2009-2016, 10-inch pipe authorized under Automatic Board Order (ABO) issued as Permit No. 11108, 1975 - D. Faria) [Additional Reference(s): LMA encroachment station (STA) reference based on Map of Evacuation Route, Reclamation District 341 Sherman Island by Wagner Bonsignore Consulting Civil Engineers, A Corporation dated July 2012, STA 743+00] FS Date: 7/6/2016

View of levee crown.

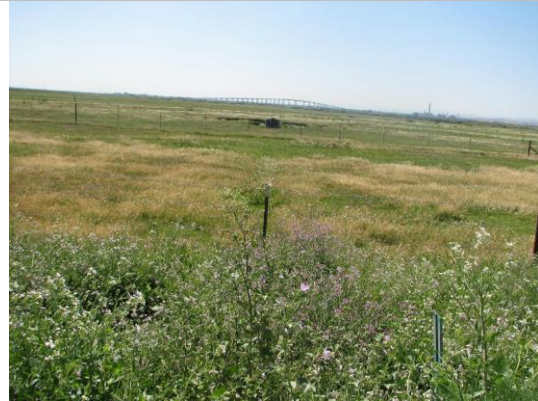
Photo 3 of 3 : UCIP\_SP\_2018\_22324\_38094.jpg

Comment Code						
Inspector Comment						
FS_ID:22324 DS_ID:24133 EP_NO: 11114 Repair Type: Non-Urgent Crossing Status: Found UCIP Comments: 7/6/2016 Meet with Joel McElroy, District Representative, at site. DWR Bay Delta Division owns pipe. Need to contact owner to determine status of pipe crossing. (DWR UCIP - O. Magana) 05/06/2009 Dense vegetation limits the inspector's visibility to identify signs of pipe failure (leaks) along the slope. Recommend removing vegetation along pipe alignment to conduct proper inspection of structure and appurtenances. (DWR UCIP - O. Magana) FIELD_STRUCT_DESC: 14-inch steel pipe of unknown purpose through the levee, 4.0 feet below the levee crown. Concrete standpipe with slide gate located on the landside (LS). Rock revetment on the waterside (WS) slope. (14-inch pipe retained under Automatic Board Order (ABO) issued as Permit No. 11114, 1975 - E. J. Trigueiro) [Additional Reference(s): DWR Levee Log, 1992. LMA encroachment station (STA) reference based on Map of Evacuation Route, Reclamation District 341 Sherman Island by Wagner Bonsignore Consulting Civil Engineers, A Corporation dated July 2012, STA 720+00] FS Date: 5/6/2009

Overview of landward side.
